Lower Colorado River Multi-Species Conservation Program

Hart Mine Marsh

2017 Annual Report

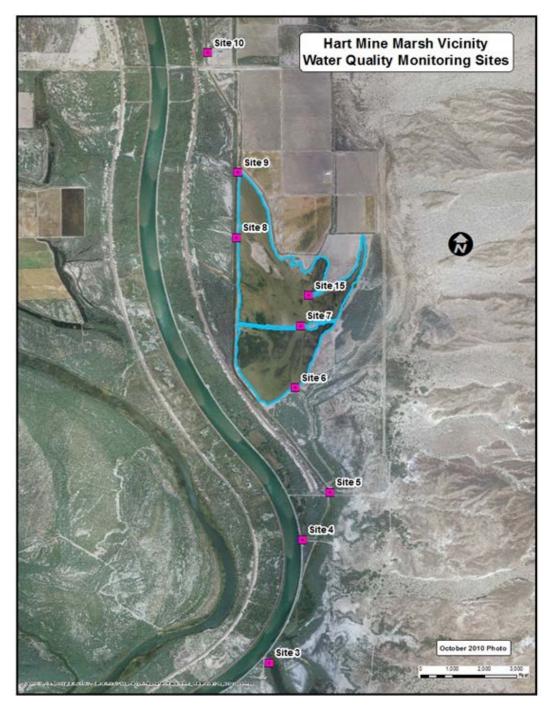
Figure 3.—HMM water quality monitoring locations.

The USFWS is responsible for monitoring and reporting on many abiotic parameters of the site as part of the interagency agreement with Reclamation. The Cibola NWR continued monthly water quality monitoring at specific points throughout the marsh. Water quality parameters including pH, dissolved oxygen, and specific conductivity (as a measurement of total salinity) were measured throughout the fiscal year. Figure 3 shows the locations (sites) where water quality parameters are measured and collected.
